MICROBE-LIFT® Removes Oil & Grease, and Hydrogen Sulfide in Pump Wells and Sewage Pipes

Location: Aarhus, Denmark

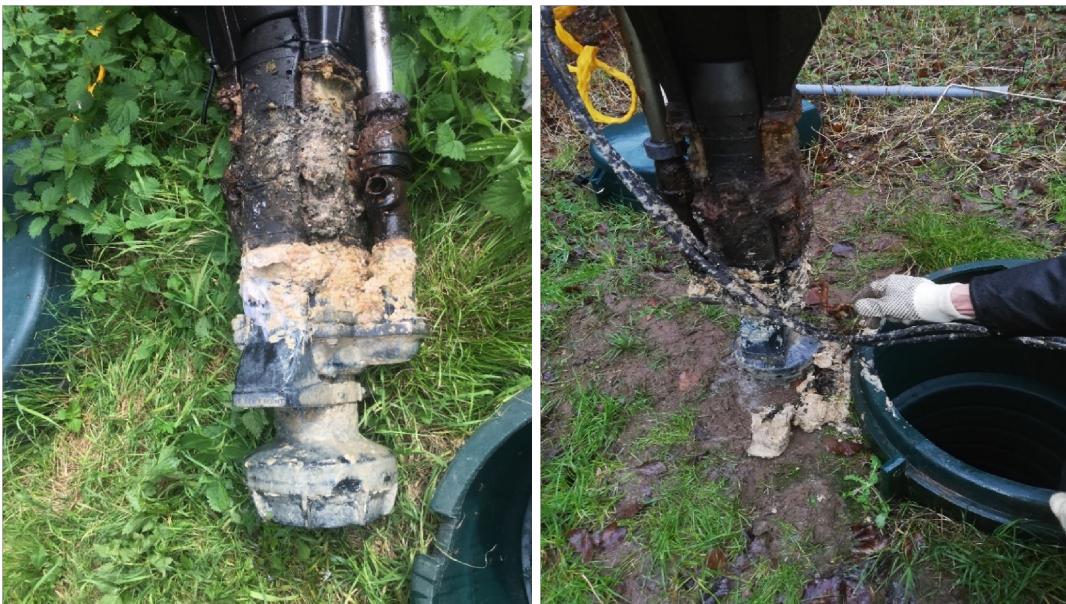
Photo 1. Pump at Skovmøllen before and after treatment (Credits: Aarhus Water)

The wastewater pipeline from the pump well at Skovmøllen and the collection well at Thaibuset near the old Moesgaard Museum shows significant improvement. Photo 1 shows that approximately 95% of the oil and grease on the pump was removed.

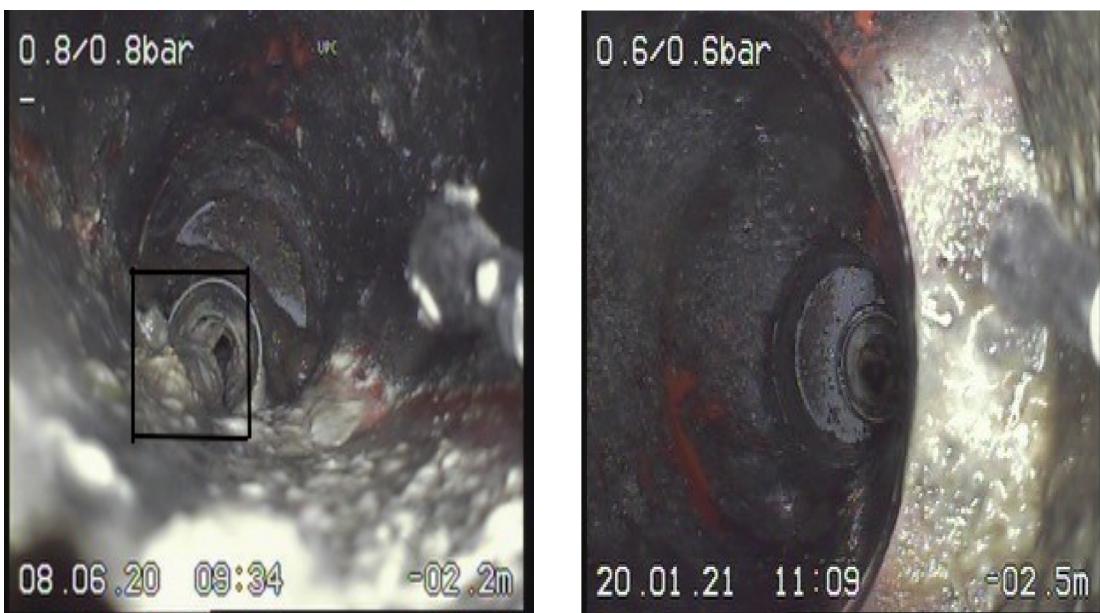
Photo 2. Collection well at Moesgaard before and after treatment
(Credits: Aarhus Water)

The pipeline survey camera photo of the sewage pipeline at the collection well before the treatment shows that a substantial part of the pipeline's cross-sectional area was blocked by grease and oil deposits. Aarhus Water stated that approximately half of the pipe's diameter of 40 mm was covered with grease before the treatment. It equates to 75% of the pipe's cross-sectional area. After the treatment, the pipeline is clean without oil and grease accumulation.

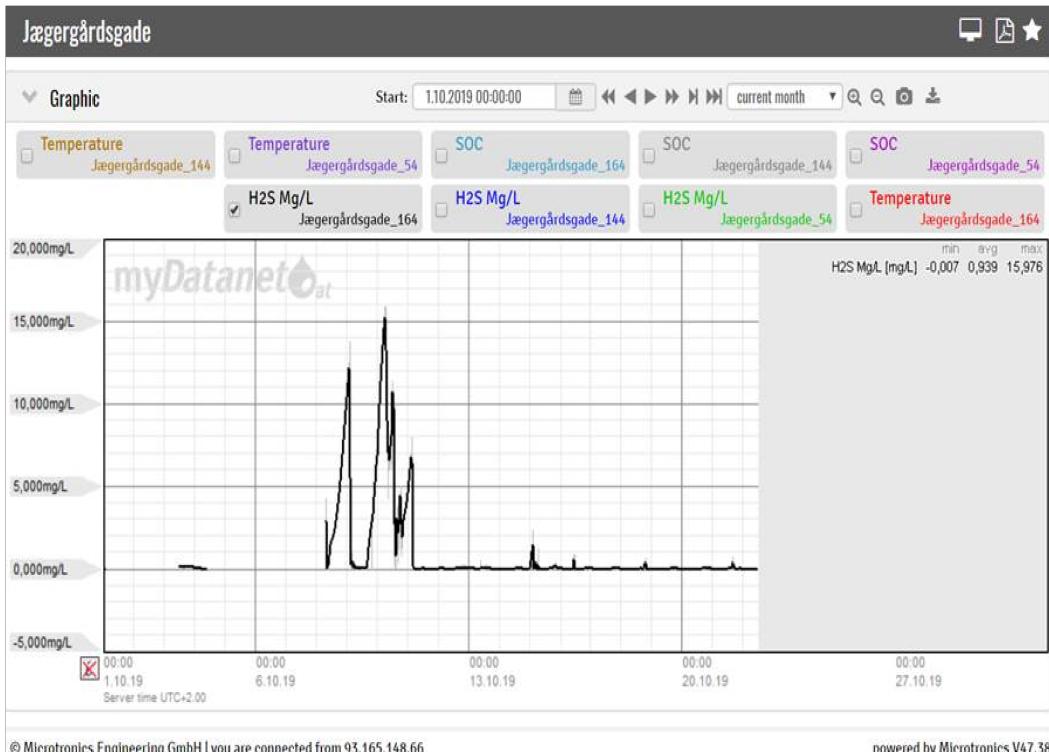
Photo 3: Monitoring of the lower section of Jægergårdsgade during the first 14 days of the treatment

According to him, from 2018 to 2019, the typical hydrogen sulfide levels above the well and water level are 5-10 ppm and 10-25 ppm, respectively. He added that after the application of the microbial solution in October 2019, the amount of hydrogen sulfide dramatically decreased. Hydrogen sulfide is no longer detected above the utility hole, and its concentration level at the water level no longer exceeded the 3ppm benchmark.

Photo 3 shows the trend of hydrogen sulfide concentration levels before, during, and immediately after the addition of bacteria on October 7, 2019. The insignificant amount of hydrogen sulfide was maintained throughout 2020. Bjarne Dagø believes that bacteria effectively reduced the amount of hydrogen sulfide in pipes and wells. The results show that a minimal maintenance dosing rate is sufficient to maintain the low concentration level after the inoculation. Aarhus Water did not observe any unfortunate side effects - not even at the Marselisborg Wastewater Treatment Plant.

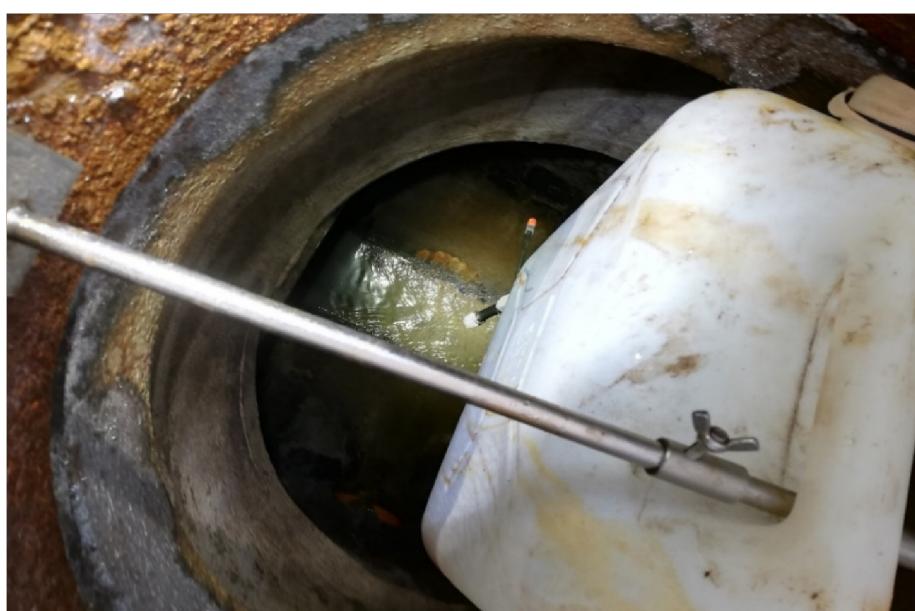
Photo 4: The dripping method used to introduce the solution well in the wastewater pipeline in Jægergårdsgade (Credits: Aarhus Water, December 2019)

The dosing is divided into two parts: 2/3 for upper end of the line at Godthåbsgade and 1/3 for the lower portion. A dripping system was later on used for maintenance. The bacteria are continuously applied with a container, pump system, and suspension in the wells. This method led to a more practical solution by adding two dosing points in the street.

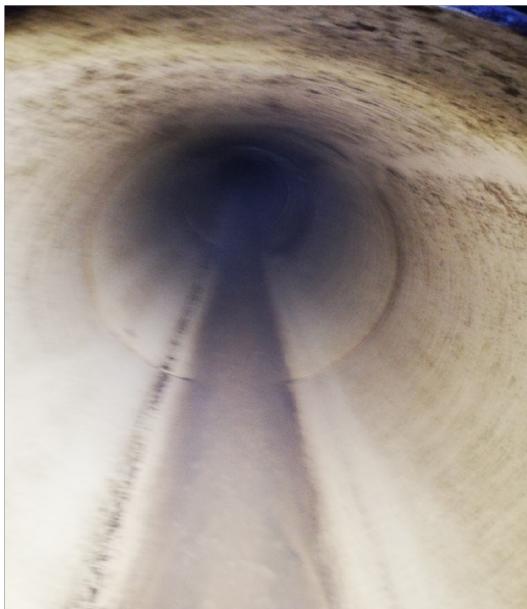
Photo 5: After the application of Microbe-Lift. The wastewater pipeline in Jægergårdsgade is solid build-up-free. (Credits: Aarhus Water, December 2019)
