## California City Reduces Lift Station Maintenance with MICROBE-LIFT® Technology

**Location:** Kerman, CA, USA

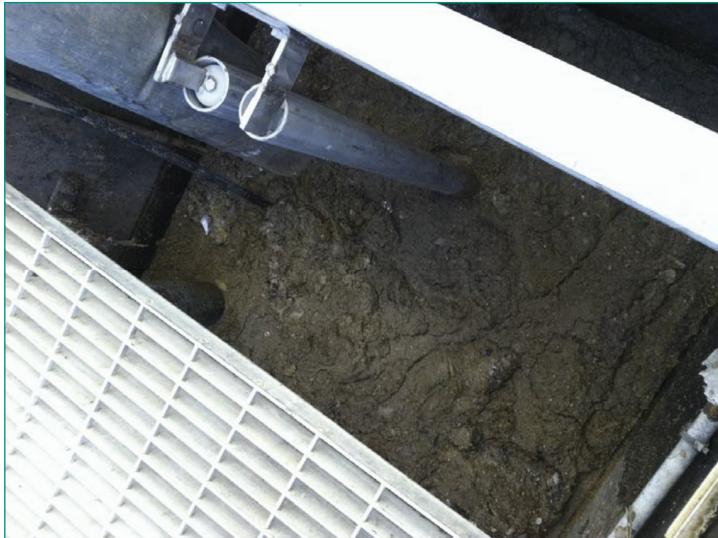
**Results Achieved:** The results of treatment with **MICROBE-LIFT®/IND** were dramatic as depicted by the pictures below. Before treatment on February 8, 2012 the lift station pictured below was heavily impacted with grease and scum.

**Fig. 1:** With the grate open, a 2 - 3 foot grease layer is evident prior to treatment.

Initially both the wastewater and collection wells were each dosed once with 3 gallons of **MICROBE-LIFT®/IND**. Thereafter 1 gallon was added to the collection pit daily for four days. Starting on the fifth day, the system was maintained on a dosage of 1/2 gallon per week.

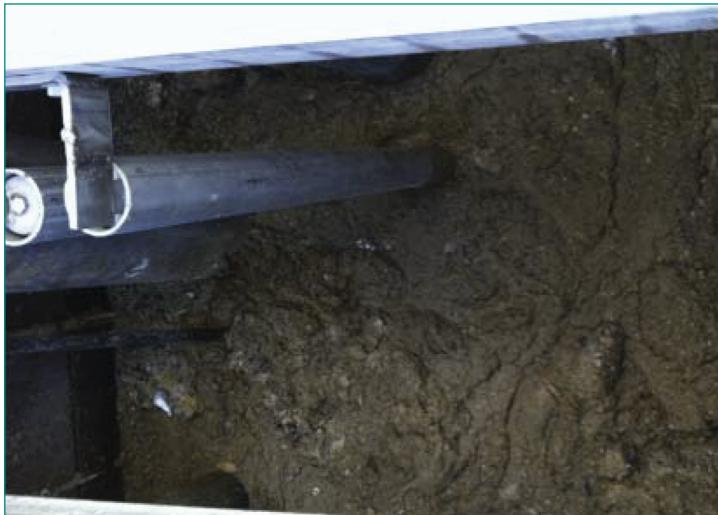
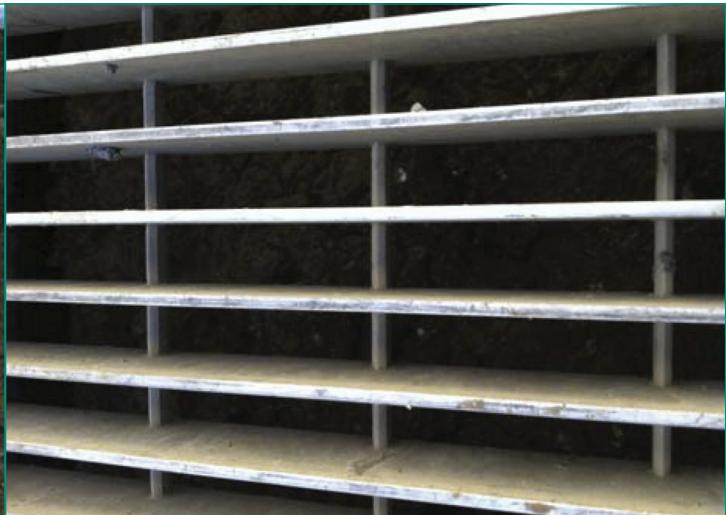
**Fig. 2 & 3:** These pictures show a side view with gate open and a top view with gate closed.

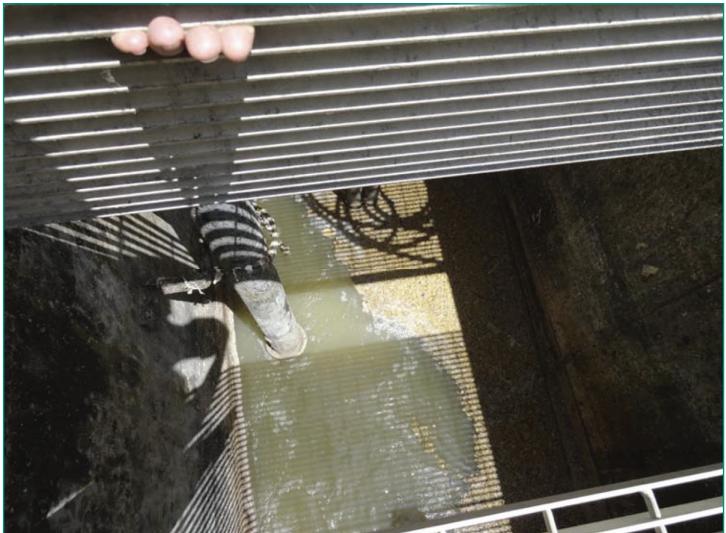
**Fig. 4:** May 18, 2012 after three months of treatment, the grease cap has not returned.

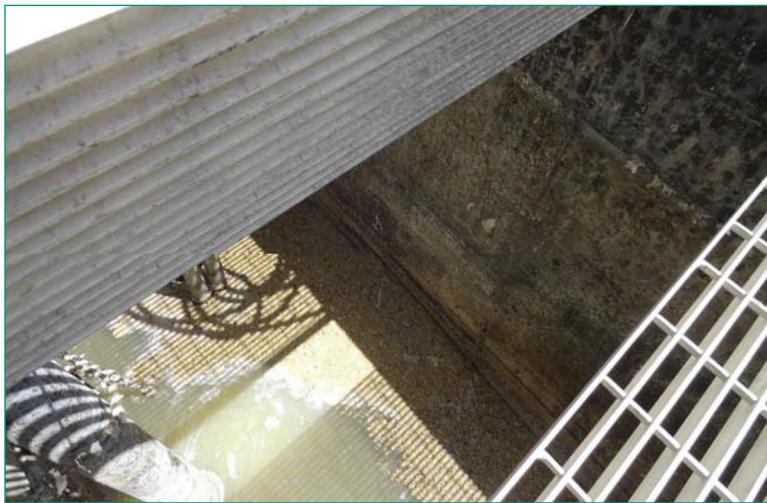
**Fig. 5 & 6** These pictures further demonstrate the lack of new buildup of the grease cap when seen from a side view and through the grate from the top.

After three months with only the maintenance dose of  $\frac{1}{2}$  gallon per day being applied, the grease layer has not returned.
